SERVICE BULLETIN

from: TRIO-KENWOOD COMMUNICATIONS, INC.

SUBJECT: ALTERNATOR WHINE, TR-7600/7625

DATE July 9, 1979

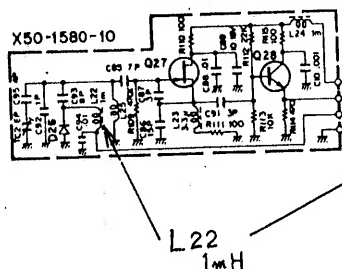
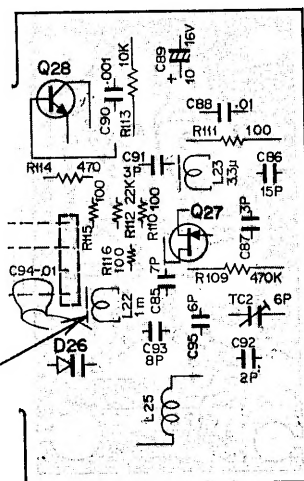
■ PLL UNIT (X50-1580-10)

In some mobile installations, alternator whine may be heard during transmit. External B+ filtering does not have sufficient effect.

If all of these measures fail, replace L22 on the VCO unit X50-1580-10 from the original green coil, to either an orange or black coil. No adjustments should be necessary.

Old part number L40-1021-03 1mH
New Part number L40-1021-43 1mH
